Defects of insulation systems and their negative effect on the accumulation and energy saving

Keywords: thermal insulation system, bonding, gap.

Abstract. Defects in heat insulation systems caused by incompliance with technological procedures and by human error in the course of their implementation negatively affect energy accumulation and saving. The result is thermal bridges and lower energy saving than expected in the stage of heat insulation project preparation.

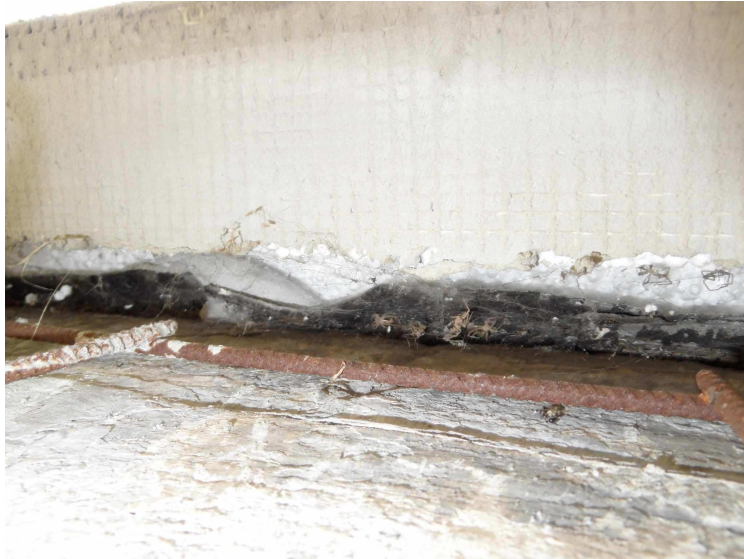
If the above principles are not observed and the insulation boards are glued other than as prescribed by the standards (such as with butts only without the bead along the board perimeter) (Figure 1) thus incorrectly implemented facades can suffer damage. Significant reduction of adhesion and stability may cause destruction of the facade. Incorrectly glued boards can also be subject to cyclic deformations (repeated sagging) causing bulging of the plaster and development of cracks in the points of board contact.

Another important fact is that the developing cold air under the heat insulation boards cools the peripheral construction a negatively affects heat accumulation and energy saving.

Figure 1: Gap between peripheral wall and its heat insulation, incorrect gluing of heat insulation boards

- The glue is applied manually or mechanically on the reverse side of the board in the form of a bead along the board perimeter and to the middle either in the form of butts (at least three per board);
- In the case of mechanical application in the form of an irregular bead;
- In the case of ETICS connected to the base with the glue only at least 40% of the foam polystyrene insulation board surface must be glued to the base, unless otherwise specified in the building documentation.

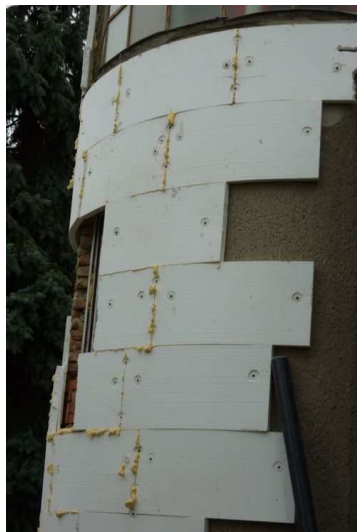
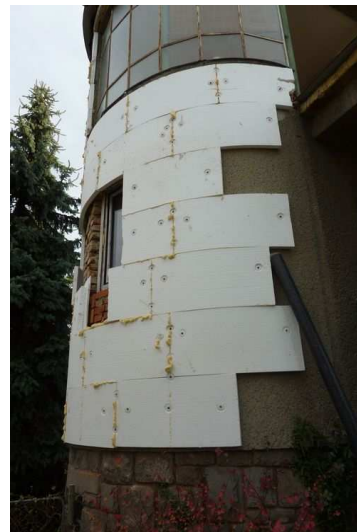
Figures 2, 3: Inappropriate heat insulation of circular sections of building

Edges of individual boards are separated from the wall forming gaps between the wall surface and the insulation agent (Figure 2, Figure 3).

This results in development of thermal bridges. However, this is not the only problem connected with energy saving.

A much bigger problem occurs in the course of plaster levelling. As the wall is circular and cannot be exactly levelled by grinding, the layer is thicker in places. This also results in thermal bridges, with subsequent increase of relative humidity in the interiors, development of wet maps and mould. In such cases the surface finishes of the construction can be damaged or completely degraded, the change of contact thermal insulation material properties happens. Thermal bridges could negatively influence the inner microclimate. [1], [2]

For that reason it is better to use mineral wool with perpendicular fibre which easily follows the construction shape and can be ground to made a level surface, which eliminates problems caused by application of polystyrene.

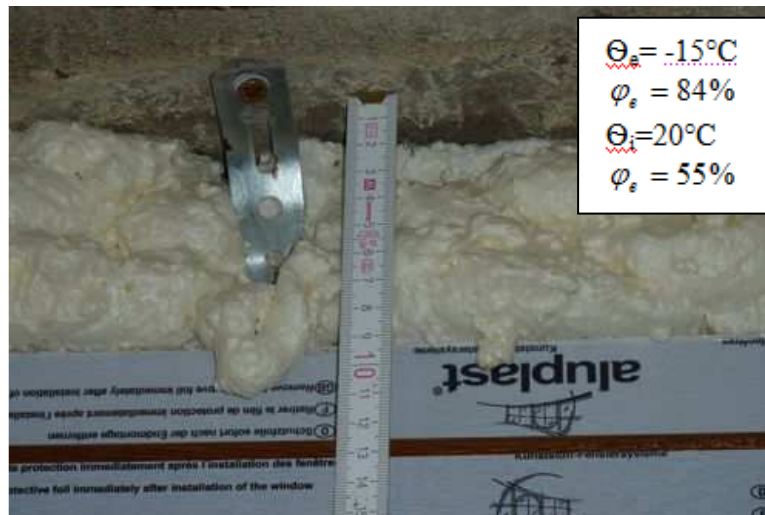
Larger gaps are not unusual, often up to 10 cm. (Figure 4)

Figure 4: Gap size between the window and the reveal 10 cm.

In this case air humidity is the issue. Air humidity takes the form of vapours both in the interior and in the exterior. When the existing non-tight windows are replaced with perfectly sealing heat insulated window systems humidity increases especially in the warm interiors. The humidity can be absorbed by the construction. The absorbing constructions include polyurethane assembly foam which is used for filling connection gaps. Connecting gap is a place where the window is anchored to the wall. The gap also represents the transition of the window opening to the masonry of the wall. The user places maximum demand on thermal technical requirements for these spaces.

In winter vapours condense in the PUR foam layer on the cold side of the connection gap towards the exterior due to cooling, which reduced heat insulating properties of the joint. As a consequence of non-ventilated humidity on the interior side of the connection gap heat loss and mould develop.
