# APPLICATION OF RISK ANALYSIS FOR BUILDING EVALUATION

**Abstract.** For evaluation of technical condition of the buildings their constructions, you can use the methods of risk analysis. These methods may be used for pricing building and construction, depending on their condition, age and use During the subsequent design of the reconstruction or rehabilitation must always consider the scope and extent of the selected type of reconstruction in relation to the potential of harm (physical and financial). In the paper is applied to building assessment the method of universal matrix of risk analysis (UMRA).

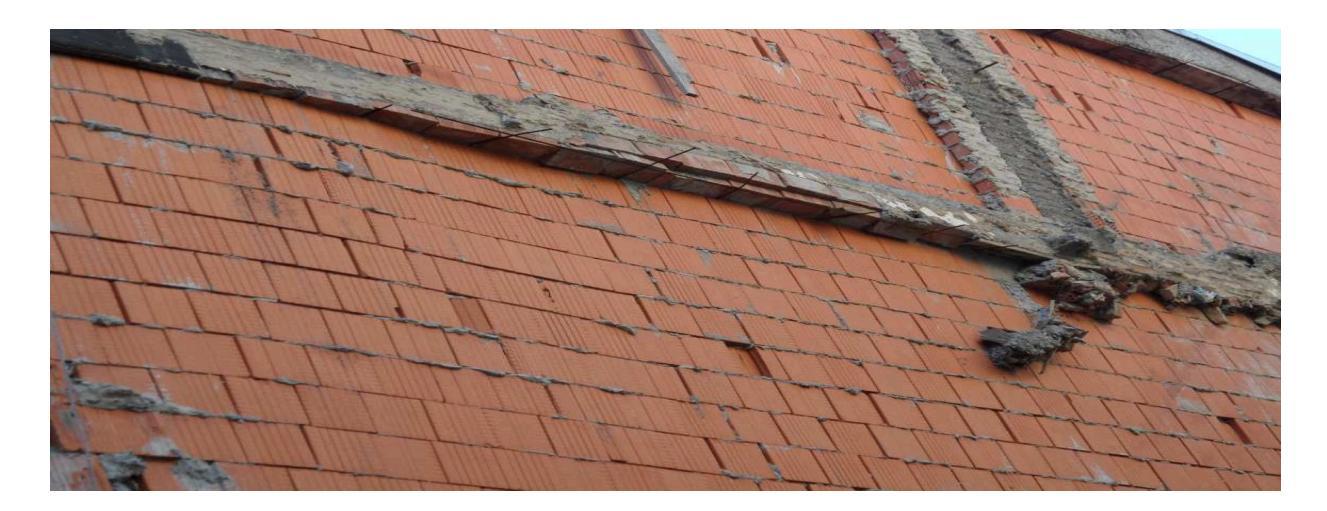
Figure 1: Damaged bearing structure of the building, which are assessed in tab. 2

The universal matrix of risk analysis [1, 2] will be used to assess the condition of the peripheral supporting structures from ceramic bricks. The ceramic bricks are disrupted and damaged by a overloading in some places. The risk analysis was performed by a team of four experts (working group). The working group was managed by an analytical expert. The structures were evaluated by according to the following table. The table shows the degrees of severity of the damage state of the structure depending on the actual situation.

Project	Structural damage						
Segments of the	Sources of danger						
project	Mechanical wear	Material	Cracks				
Expert No.1							
Vertical structures	2	3	4				
Wreaths	3	3	3				
Expert No.2							
Vertical structures	3	4	3				
Wreaths	Wreaths 3		-				
Expert No.3							
Vertical structures	3	3	3				
Wreaths	3	4	2				
Expert No.2							
Vertical structures	4	4	3				
Wreaths	3	3	4
