Application of risk analysis by the evaluation of buildings indoor environment

Evaluation of administrative building using the risk analysis

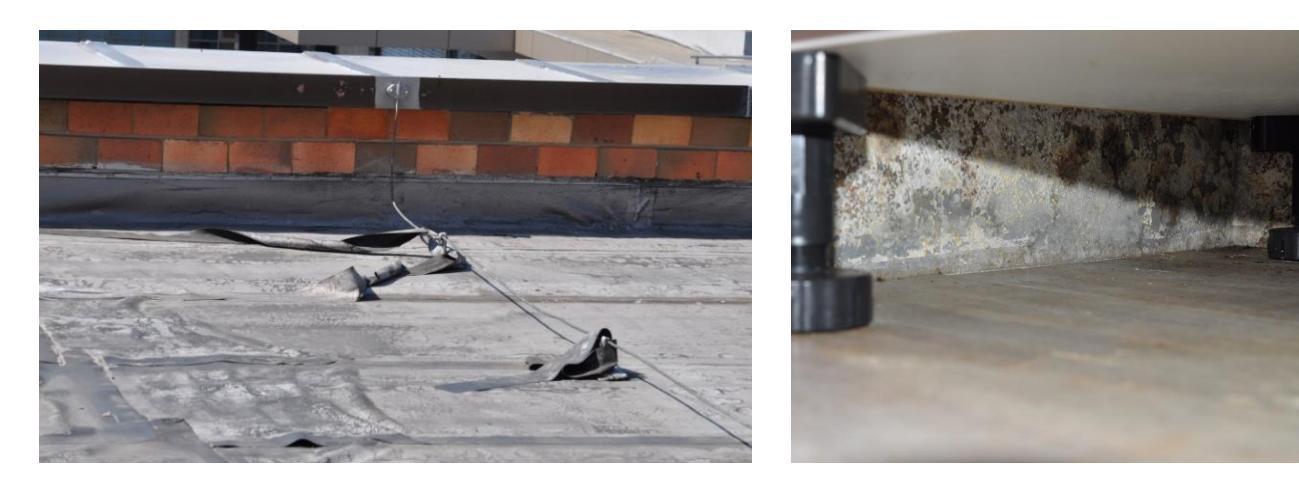
The office building object in question, its external cladding is formed by steel load-bearing structure of atypical shape and beam filling shows serious defects at some places. During heavy rains the rainwater leaks in the contact points of these two structures. This in-leak results in mould formation in the interior which has negative impact on hygienic conditions of the indoor environment. The indoor environment quality is also influenced by acoustic properties of the designed constructions. [1, 2 and 3]

Figure 1, 2: Damaged flat roof waterproofing and rot of the administrative building evaluated in the tab.2

At evaluation of the administrative building condition using the risk analysis method the defects of roofing and external cladding were assessed by the expert team as the most serious ones. The risk analysis results serve as a supporting background for officially appointed expert. A suitable maintenance of the object will be recommended upon the risk analysis of the administrative building. Moulds formed inside the object due to its age and insufficient maintenance of it during use which have negative impacts on health of users and comfort of the indoor environment. On that ground the value of the real estate is reduced.
