Risk analysis of asbestos structures and their impact on the internal environment of buildings

Keywords: asbestos, risk analysis, internal environment

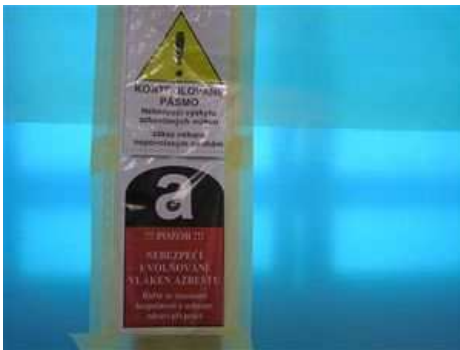
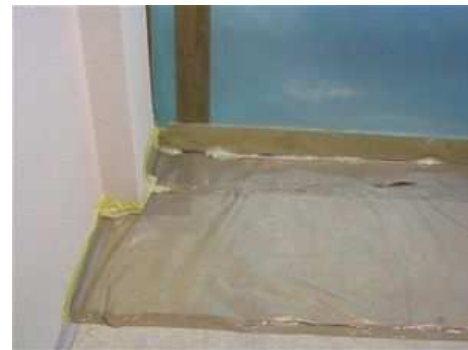
Fig. 1, 2: Controlled area for handling with asbestos products [2]

- 1) analysis of asbestos presence in the building is carried out;
- 2) the intention shall be discussed with particular surveyor's office (notification, building control – provision of relevant documentation);
- 3) around the place of future remediation works a so called control area shall be established which will be made from boards and reinforced foil, sealed with PURR foam and band. In this way the spread of asbestos fibres to the surrounding area is prevented during the works;

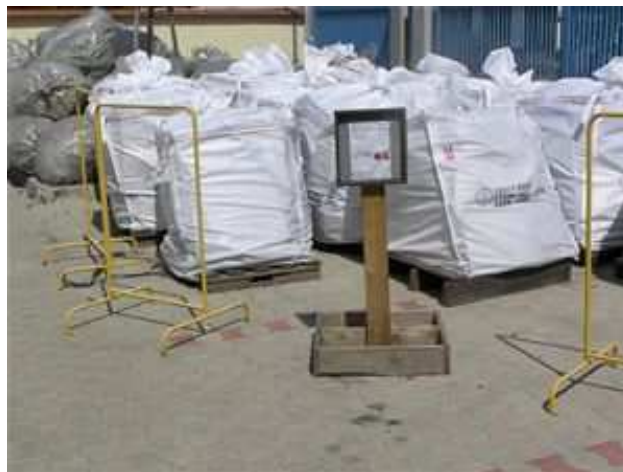
Fig. 3: Safe liquidation of asbestos waste [2]

- 4) material stabilisation shall be made and the material will be removed in a special regime which prevents scattering of asbestos fibres - moistening of dismantled materials with water or the asbestos materials are sprayed with polymer materials before the dismantling;
- 5) the area is decontaminated;
- 6) measurement of occurrence of asbestos fibres will be provided in the area after decontamination. Only independent accredited laboratory may perform the measurement. The limit set by the MHZ Regulation no. 6/2003 is 1000 fibres/3^M for internal environment of selected stay rooms;
- 7) waste liquidation – the wastes with asbestos content can be removed only in the equipment and upon the conditions set according to § 35 of the Waste Act no. 185/2001 and other related regulations. [1, 2, 3 and 4]
